ROCHESTER HISTORY

The Sleeping Giant **The Story of the Mt. Morris Dam**

by Ruth Rosenberg-Naparsteck

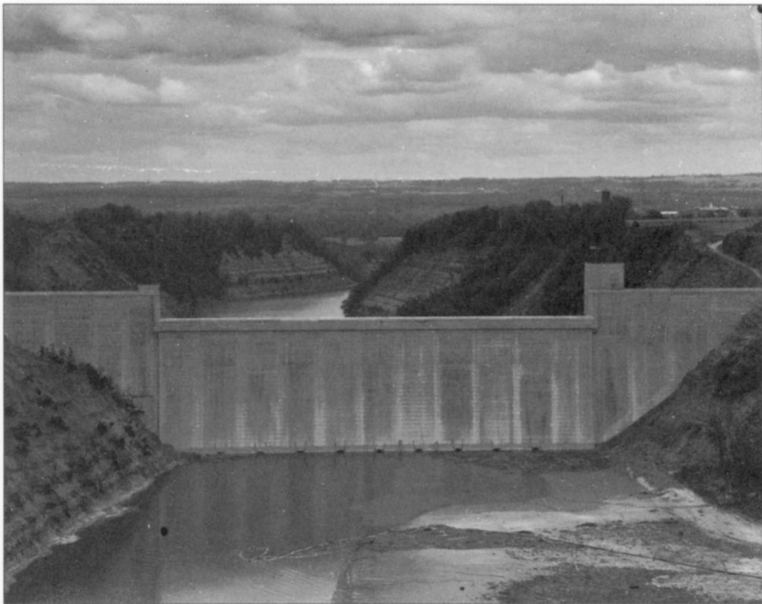
Front Cover: The Sleeping Giant-the Mt. Morris Dam-stands 215 feet above the floor of the Genesee River blocking its passage and controlling its flow during high water; but most often allowing 'run of the river.' (Army Corps of Engineers)

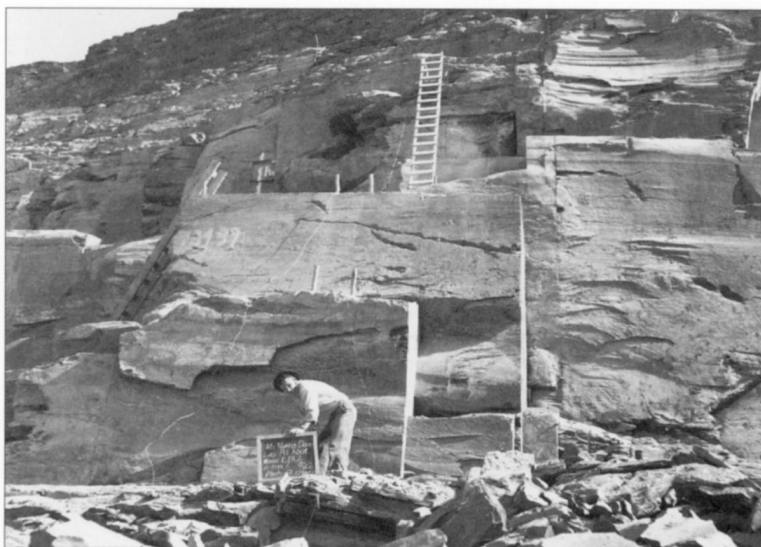
Workmen prepare to blast out stone in preparation for anchoring the dam to the gorge wall. (Army Corps of Engineers)

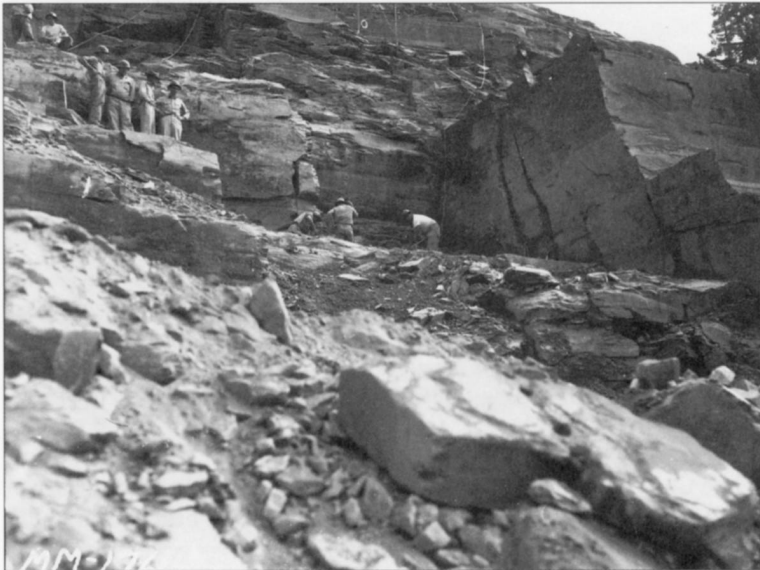
Stone is removed from the gorge wall while building the south abutment of the Mt. Morris Dam. (Army Corps of Engineers)

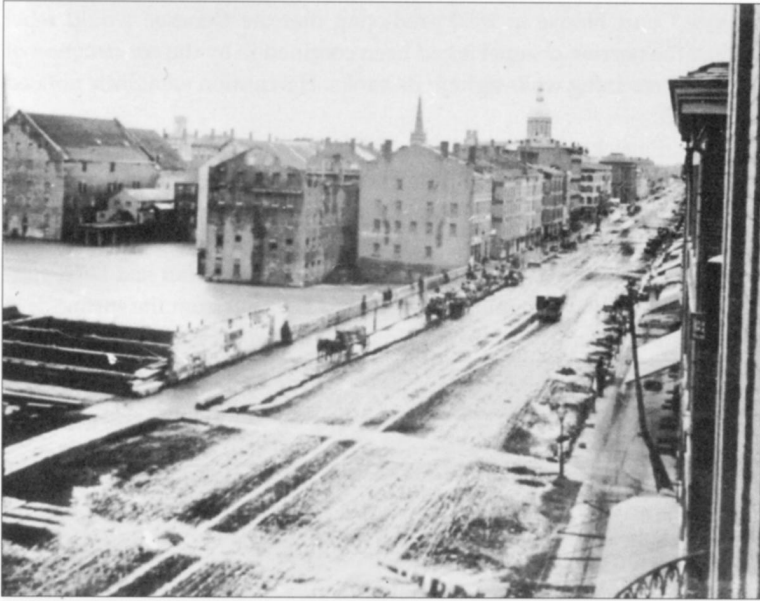
During the flood of 1865, Main Street was flooded and many of the businesses built out onto the bridge were destroyed. In this photograph, the water has receded nearly back to the river's banks. The city's Health Officer, Lyman Langworthy predicted that the buildings built tight to the river's bank, confining it in too narrow a passage, would someday bring flooding. (Rochester Public Library)

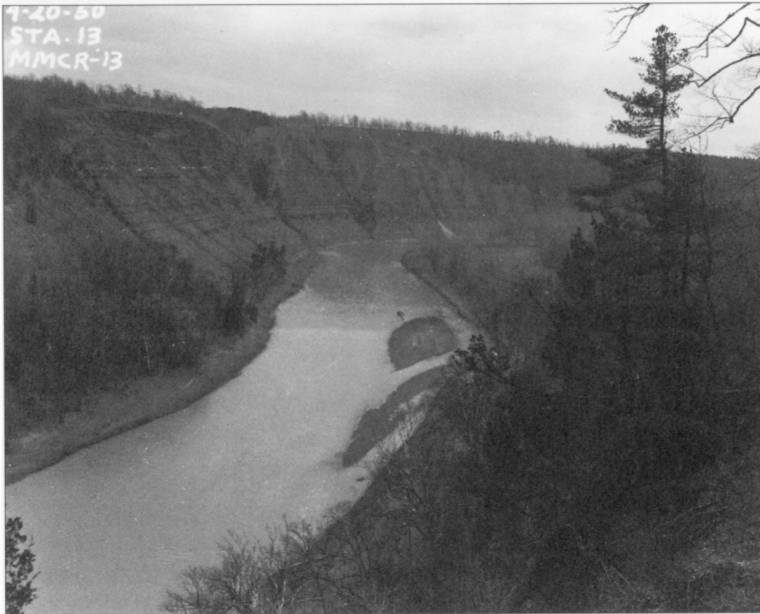
In its 10,000 years the Genesee River carved out its own confines between the gorge walls midway along its path from the hills of the Allegheny Mountains in Pennsylvania to the mouth of Lake Ontario. The Genesee River is the only river to bisect New York State. (Army Corps of Engineers)

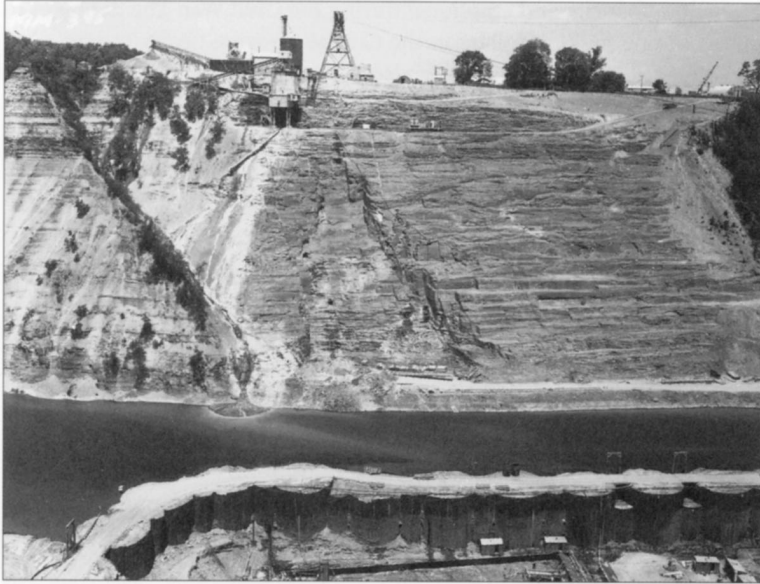
The stone was quarried in LeRoy and trucked to the dam site where it was crushed, sized and pulverized to make sand and gravel for concrete. Many materials could be had locally. There was enough concrete used in the construction of the dam to build a two lane highway 300 miles long. (Army Corps of Engineers)

The concrete and gravel was quarried in LeRoy twenty-six miles from the dam site and trucked to an on-site storage area. The stone was dumped into a hopper, crushed and screened repeatedly and sized. Small stones were pulverized to make sand. The stone and sand were conveyed to a concrete mixer that dumped two 22-ton batches of concrete into buckets set on the tracks that led from one tailtower to another. The buckets were connected to the cable and carried across the gorge to hover directly over the forms of the dam below. Every 22-ton batch of concrete raised the level of the forms five feet.

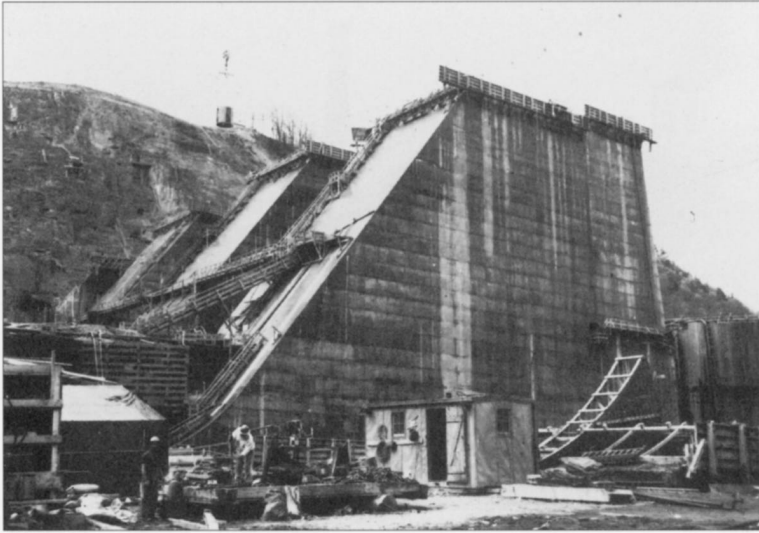
The blocks, though half completed, dwarf the workmen to the left in this photograph. Note the bucket of concrete crossing the gorge to the left of center. (Army Corps of Engineers)

Twenty-two tons of concrete were carried in eight cubic yard buckets which swung in the air carrying concrete from one side of the gorge to the other. Every five minutes night and day for three years from May through November 1949 to 1951 these twenty-two ton loads of concrete were poured into the forms.

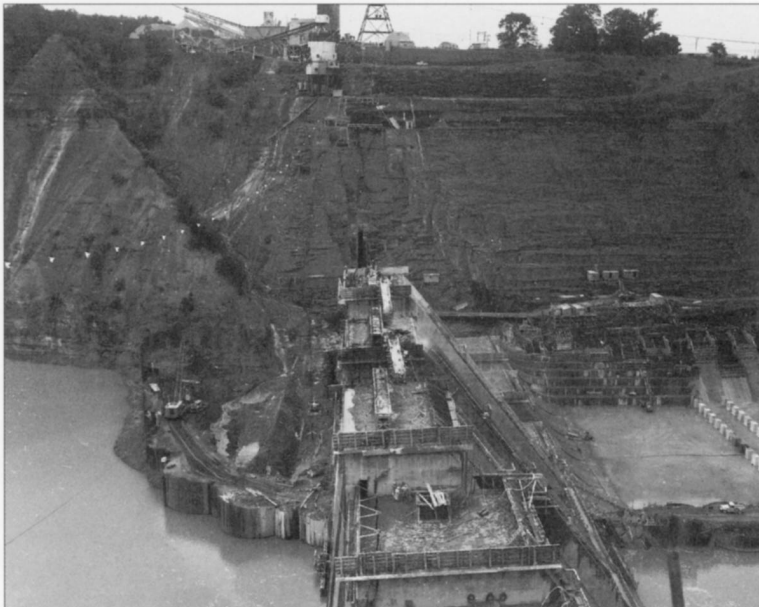
Cofferdams were built to provide dry work areas. A string of lights stretched across the gorge is visible to the left. The forms built to shape the concrete as it was poured are seen here. (Army Corps of Engineers)

Four hundred and seventy men worked on the Mt. Morris Dam during the four years of construction. Trees were cut and burned from the river flats to reduce the amount of debris the river would carry downstream. The gorge walls were blasted and cut away to carve out the keyway. A cofferdam was built to force the river to one side creating a dry area for the workers. The cofferdam was built of cells of interlocking steel sheets formed around templates and driven into the rock floor of the

river. The cells were filled with soil to weigh them and keep them in place.

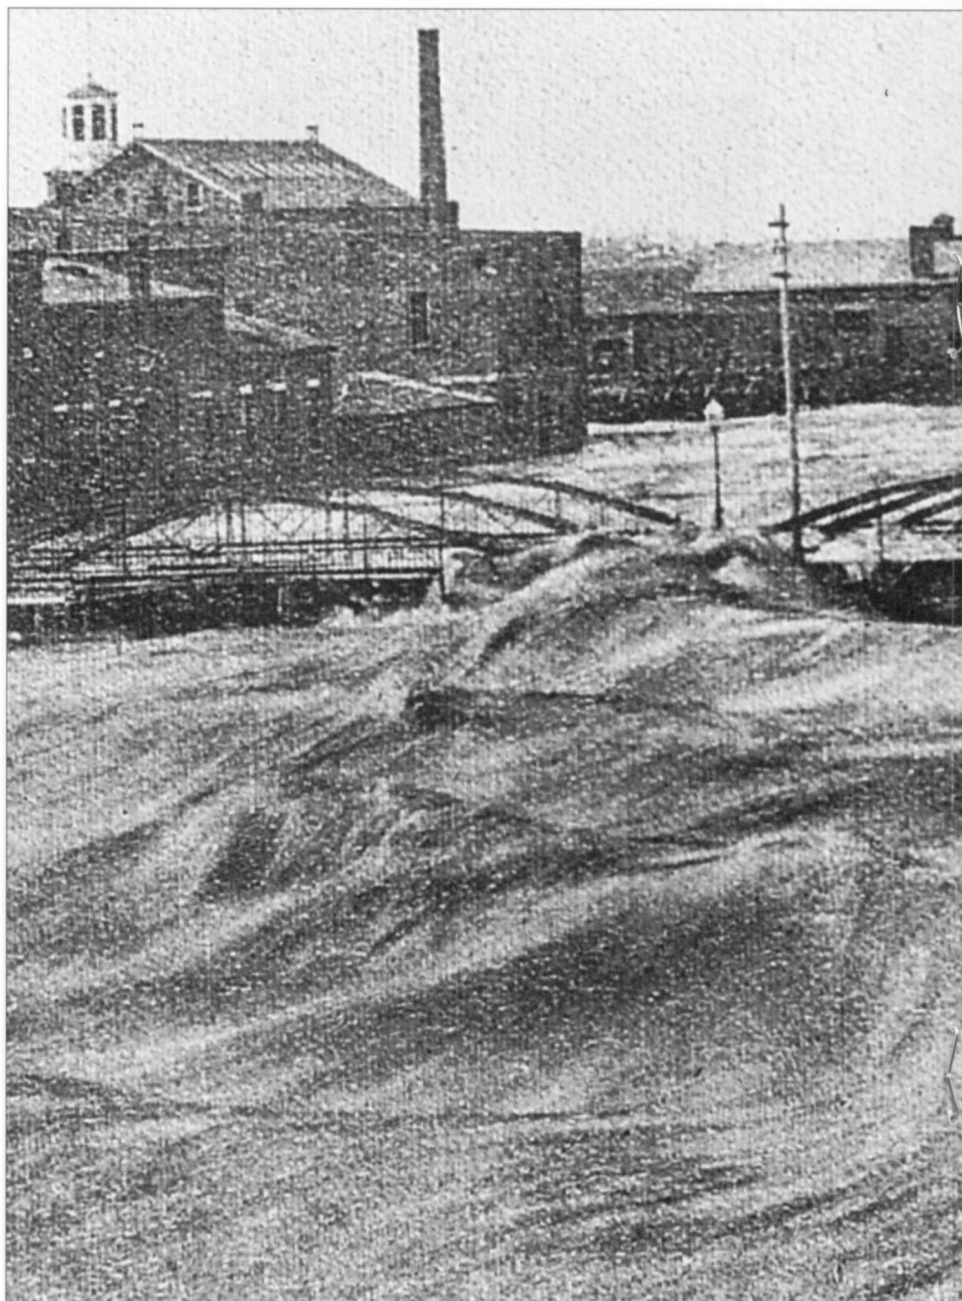
The Andrews Street Bridge was overrun by the racing waters of the Genesee during the flood of 1862, flowing through the river and into the city's streets. (Rochester Public Library)

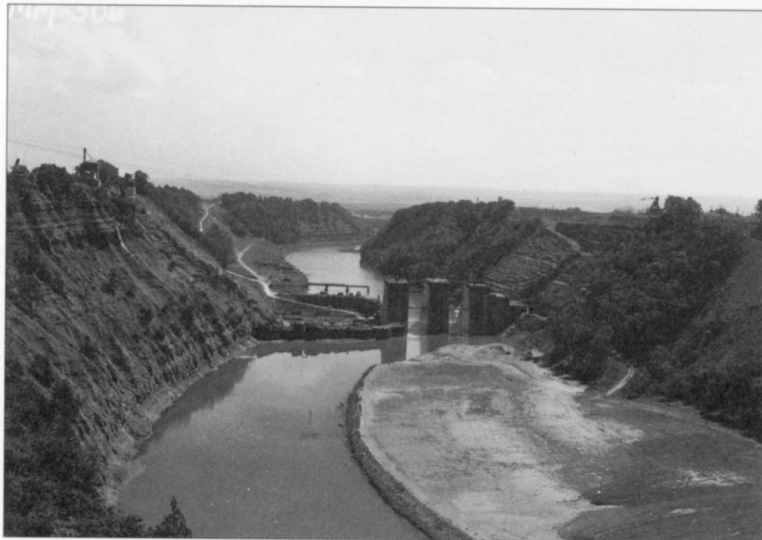
The trees and growth along the flats of the river have been removed and several monoliths or blocks, have been built for the Mt. Morris Dam. The dam took four years to complete working day and night through every season. (Army Corps of Engineers)

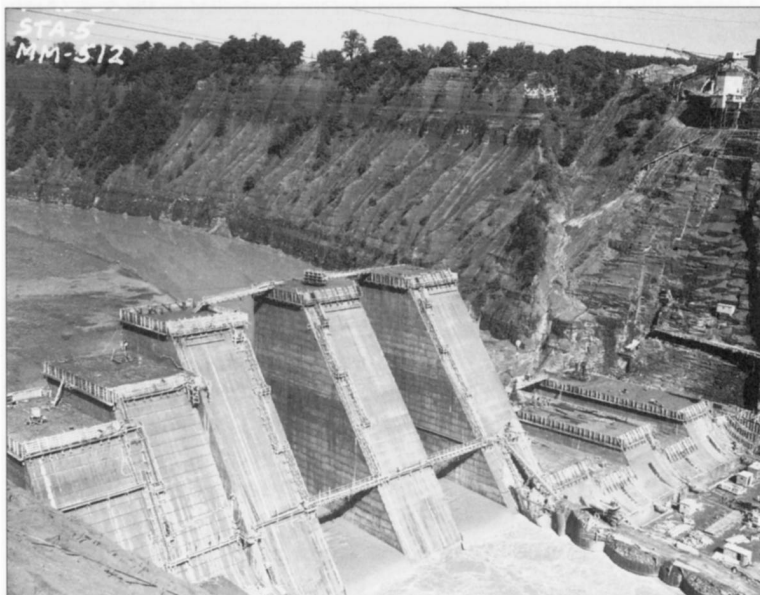
Half of the monoliths, or blocks, were left lower to allow the river to pass over during construction. Every other block was left open until near completion. The blocks are built independently so that if any one of them fails, the others will hold back much of the water. (Army Corps of Engineers)

Though development of electricity was not permitted, two 19-foot diameter tube openings were built into the dam to permit future development. Forms for conduits were built to allow the river passage. Every other block was left down to allow passage of the water while the workmen moved to build a cofferdam on the other side of the river.

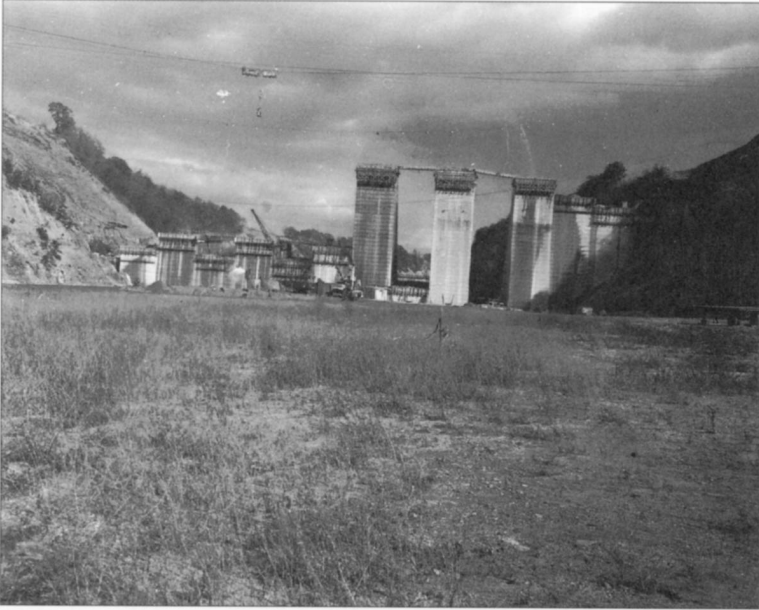
The conduits allowed the river to flow freely even before the dam was completed. A flood in 1950 before the dam was completed was controlled by the dam. (Army Corps of Engineers)

ter cold and driving winds of winter and sometimes against the flooding of spring waters. Workers sometimes pumped out millions of gallons from the area supposed to be protected by the cofferdam. The dam was half completed when it stretched across its nine conduits. As the blocks were raised to 246 feet the river began to back up. In October of 1951, the dam was completed.

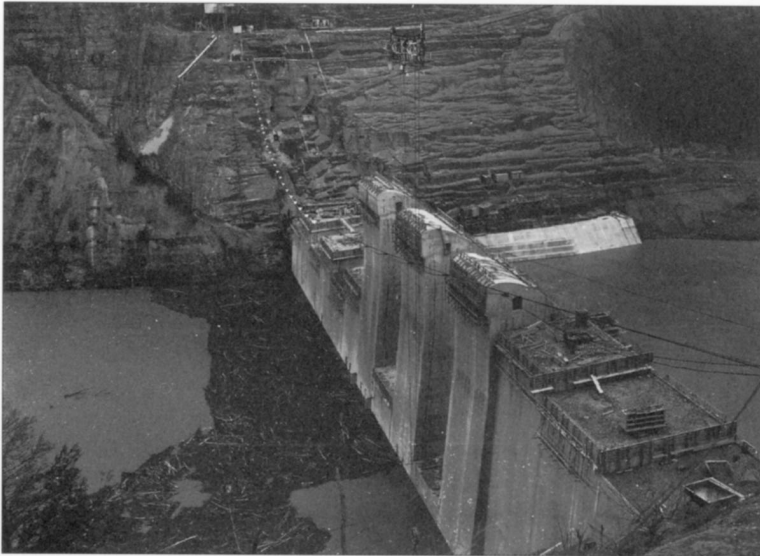
When the river was dry, the workmen could work quickly. Any debris that accumulated could be removed. (Army Corps of Engineers)

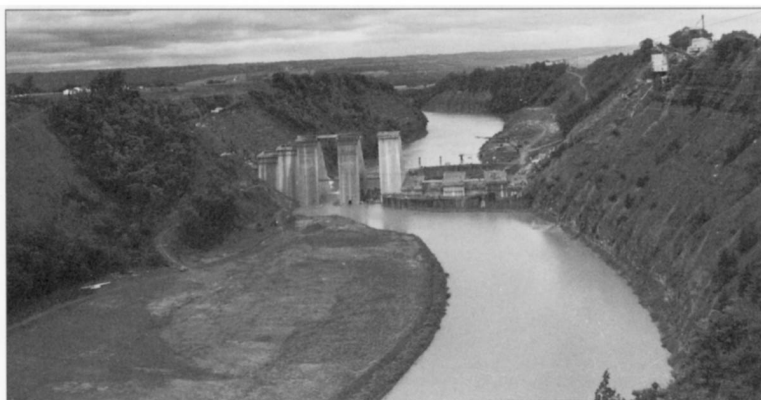
The trees are removed from the flats and the river is the same height on both sides of the partially completed dam indicating that the river is running freely. Flood waters can be held back over a seventeen mile length from Mt. Morris to the Lower Falls at Letchworth State Park. (Army Corps of Engineers)

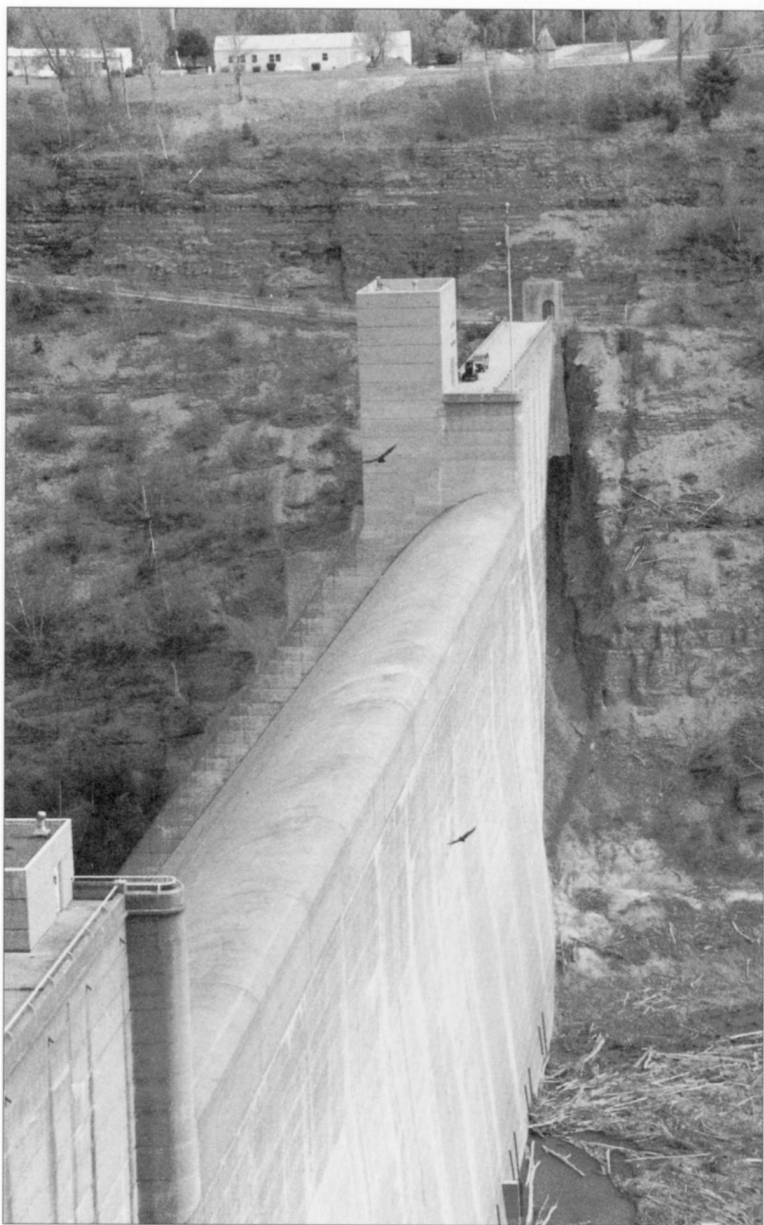
Red-tailed hawks soar above the Mt. Morris Dam in the Spring of 1994. Logs and other debris carried downstream by the river threaten to damage the bridges north of the dam. When the logs block the flow of the river under the bridges, flooding results. When the river bed is dry, workmen burn off or remove the logs to prevent them from passing over the top during high water. (Edward P. Curtis, Jr.)
